# NOAA ARRA USVI Watershed Stabilization Project

National Oceanic and Atmospheric Administration
Virgin Islands Resource Conservation & Development Council
Coral Bay Community Council

Patricia Reed Environmental Projects Manager Coral Bay Community Council This report described the projects undertaken in one of six subwatersheds in Coral Bay, St. John, USVI with \$1.5 million in National Oceanic and Atmospheric Administration (NOAA) Funding through the American Recovery and Reinvestment Act of 2009 (ARRA). These funds are part of the \$2.7 million USVI Watershed Stabilization Project funds awarded to the Virgin Islands Resource Conservation & Development Council, Inc. (V.I. RC&D). The U.S. Environmental Protection Agency (EPA) provided \$300,000 in funding to the Coral Bay Community Council (CBCC) under its Community Action for a Renewed Environment (CARE) program to provide the stormwater engineering expertise to provide the design portion of these projects and staff the CBCC Coral Bay Watershed Management Project. Local homeowners associations, the Virgin Islands government, and community volunteers have also provided more than \$400,000 in resources and worked cooperatively to

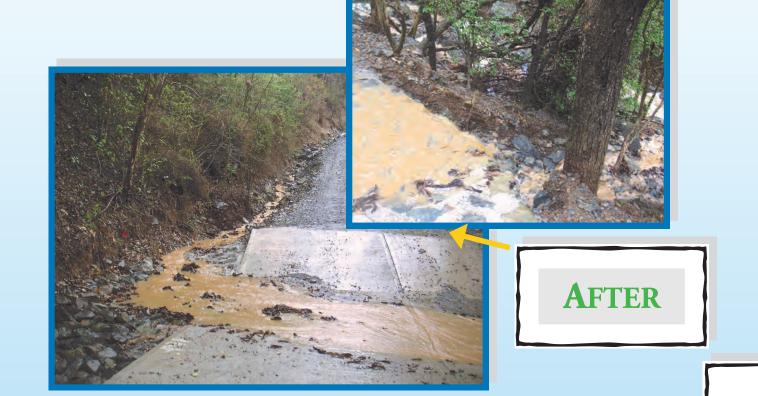
# Johnny Horn Trail Drainage Basin EPA CARE and NOAA-ARRA Partnership Small Drainage Basins

Drainage from the Johnny Horn Trail watershed has a significant negative impact on the turbidity of inner Coral Bay Harbor. The natural drainage in the watershed has been disrupted by recent road construction and maintenance by track hoe. This map shows the Johnny Horn Trail area, sub-basins, natural drainage flow, pre-existing and new drainage structures. It also shows the old (red) and natural (blue) water routes.

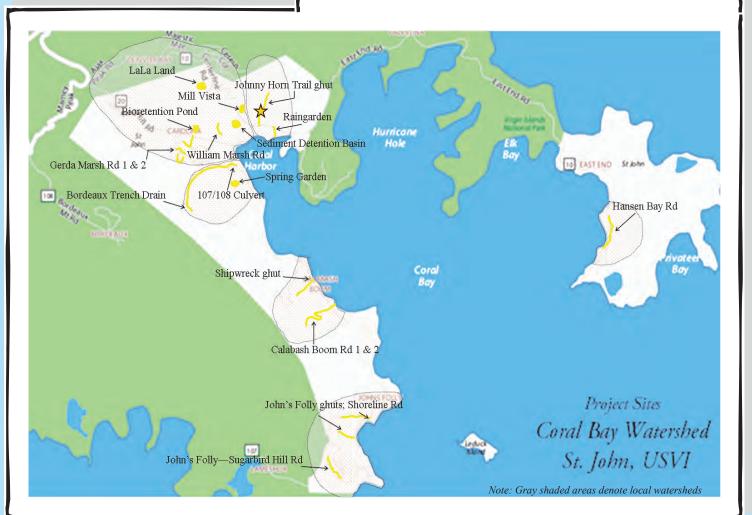
# SITE LOCATIONS

Watershed scale Geographic Information System (GIS) planning tools targeted water QUALITY MONITORING RESEARCH THAT HELPED IN SELECTING THE PRIORITY SITES FOR THESE SEDIMENT REDUCTION PROJECTS. FOLLOW-UP TERRESTRIAL AND MARINE SEDIMENT QUANTIFY AND DEMONSTRATE THE SUCCESS IN REDUCING SEDIMENT POLLUTION REACHING THE BAY
